THERMAL IMAGING AND THERMAL STRESS ANALYSIS OF THE IMPACT DAMAGE OF COMPOSITE MATERIALS

Lovre Krstulović-Opara^{1a}, Branko Klarin^{1b}, Pedro Neves² and Željko Domazet^{1c}

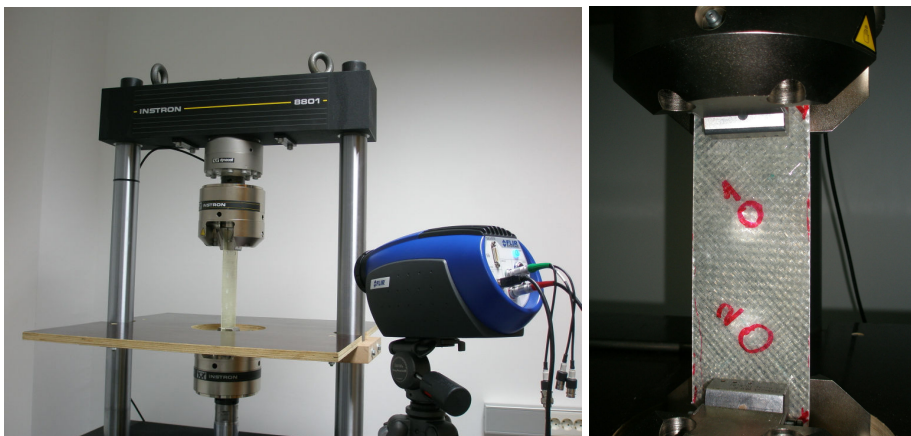
Fig. 1. TSA and damaged specimen

2nd step: TSA of the cyclically loaded damaged composite (Fig.1). The TSA is based on the infrared camera (IR) and the Lockin.

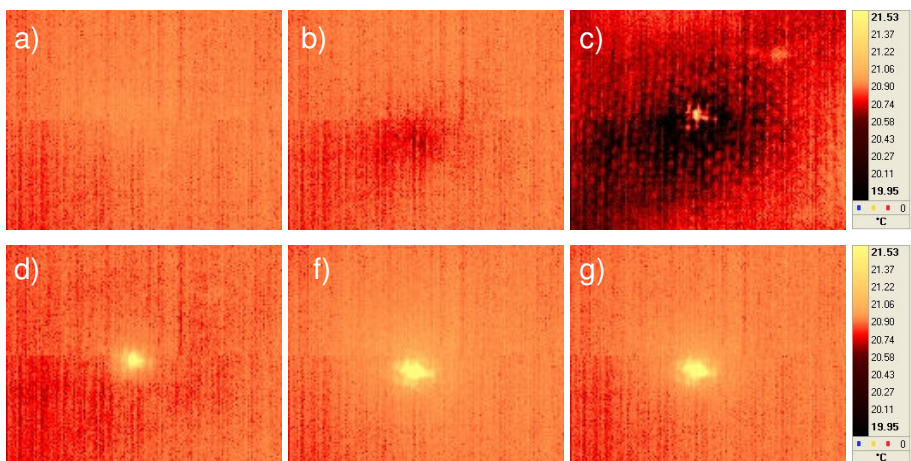
Fig. 1: Consequent images of thermal distribution during the impact at frame rate of 360 Hz

1st step: the controlled impact and high frame rate thermal imaging of a four layered 490g/m² fiberglass roving for polyester resin impacted with a 19,61 J impactor. Impact is filmed from the opposite side by a cooled IR camera at 360 Hz frame rate.

Every material in elastic tension cools for a short instant, while heats for the case of elastic compression. For a plastic/damage case, the thermal energy is generated and heat can be observed for a while. Fig. 2a shows the moment before the impact. Fig. 2b shows cooled (elastic tension) zone under the impactor. Fig. 2c shows heated zone where the damage in material occurred surrounded by the cooled elastic zone. The last three figures show generated heat in the damaged area after the impact.

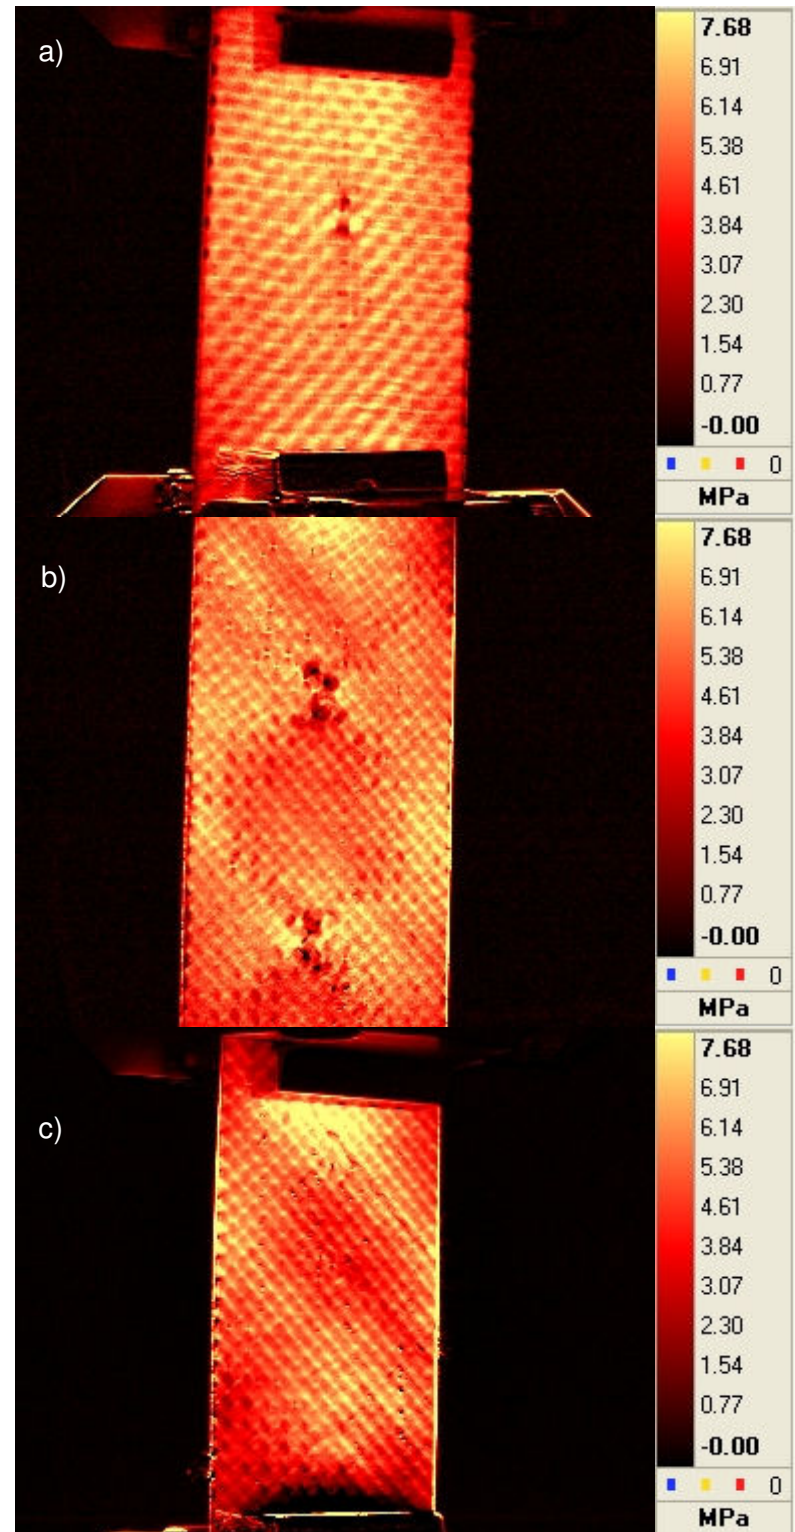
Fig. 2: Stress distribution for a) damaged 0° fibers, b) damaged ±45° fibers and c) intact ±45° fibers specimen

Fig. 3 shows the stress distribution of damaged and intact specimens. For the damaged specimens, the 0 MPa stress at the point of impact is caused by the fact that damaged glass fibers cannot carry load.
